Lagoon degradation and management in Yanuca Channel on the Coral Coast of Fiji

James P Terry¹, Priya Kisun, Aminiiasi Qareqare, Jyotishma Rajan

¹*School of Geography, Faculty of Islands and Oceans,
The University of the South Pacific, Suva, Fiji
terry_j@usp.ac.fj*

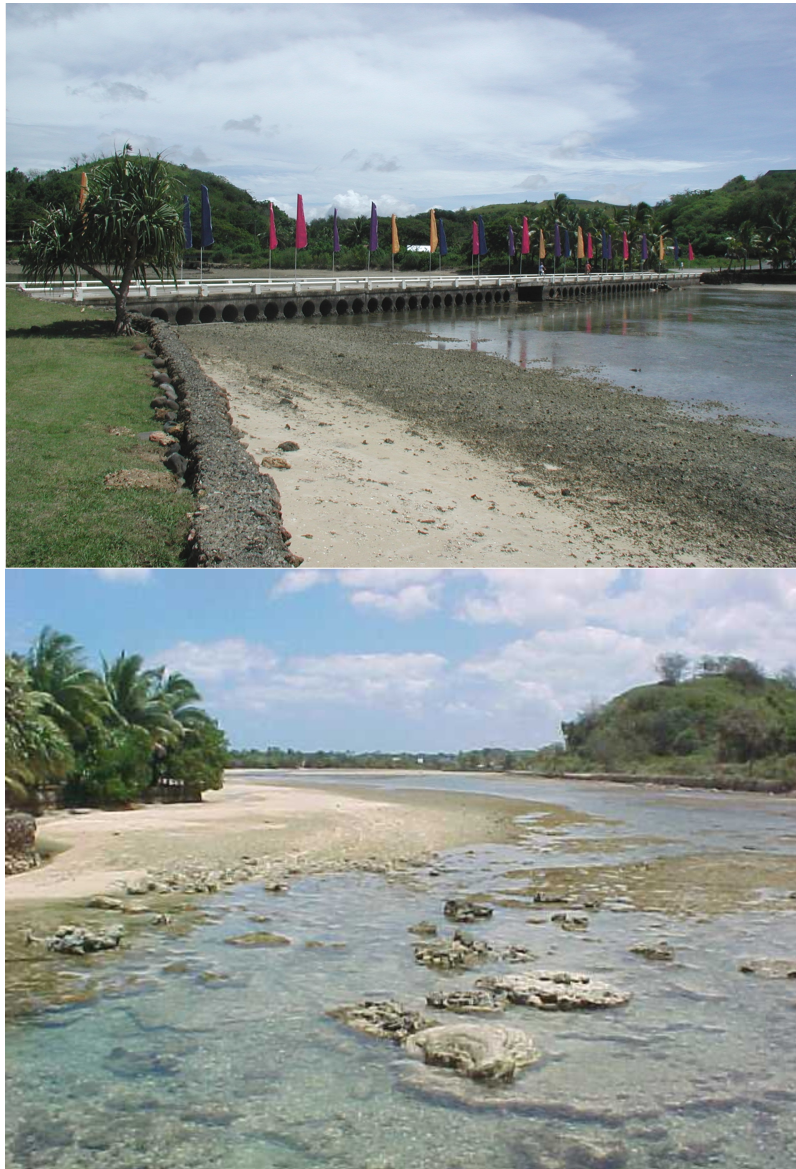
Figure 2. Top: Modern view of the resort causeway linking Yanuca Island with the mainland. Bottom: Yanuca Channel lagoon, downstream of the causeway at low tide, revealing dead corals and sand accumulation

people from nearby villages and the surrounding area. Prior to the start of resort development in 1966, a causeway was constructed, linking the mainland to Yanuca Island in 1964 (Figure 2).

Yanuca Channel is a shallow marine lagoon (Figure 2), the floor of which is partially exposed at low tide. The lagoon has a microtidal environment with a spring tide range of only 2 m. The Nalovo Creek drains into the lagoon near the narrowest section of the lagoon, immediately north of the causeway. On both incoming and outgoing tides, current flow through Yanuca Channel is always in the same direction, coming from the south entrance to the ocean and exiting into Cuvu Bay. This is in response to the influence of the South East Trade Winds and breaking waves constantly dumping large volumes of water onto the fringing reef flat. These primary current-generating mechanisms cause the prevailing current to flow into the south end of Yanuca Channel at all phases of the tide. The flow is stronger during high tide when there is less protection afforded by the fringing reefs.

The 94 m long and 4 m wide concrete causeway across Yanuca Channel was constructed in 1964 to link Yanuca Island with the mainland. The average height from the top of the causeway to the lagoon floor is 1.67 m. The causeway has an 'Irish crossing' design, with a level access road built over 57 concrete culverts (Figure 2) to

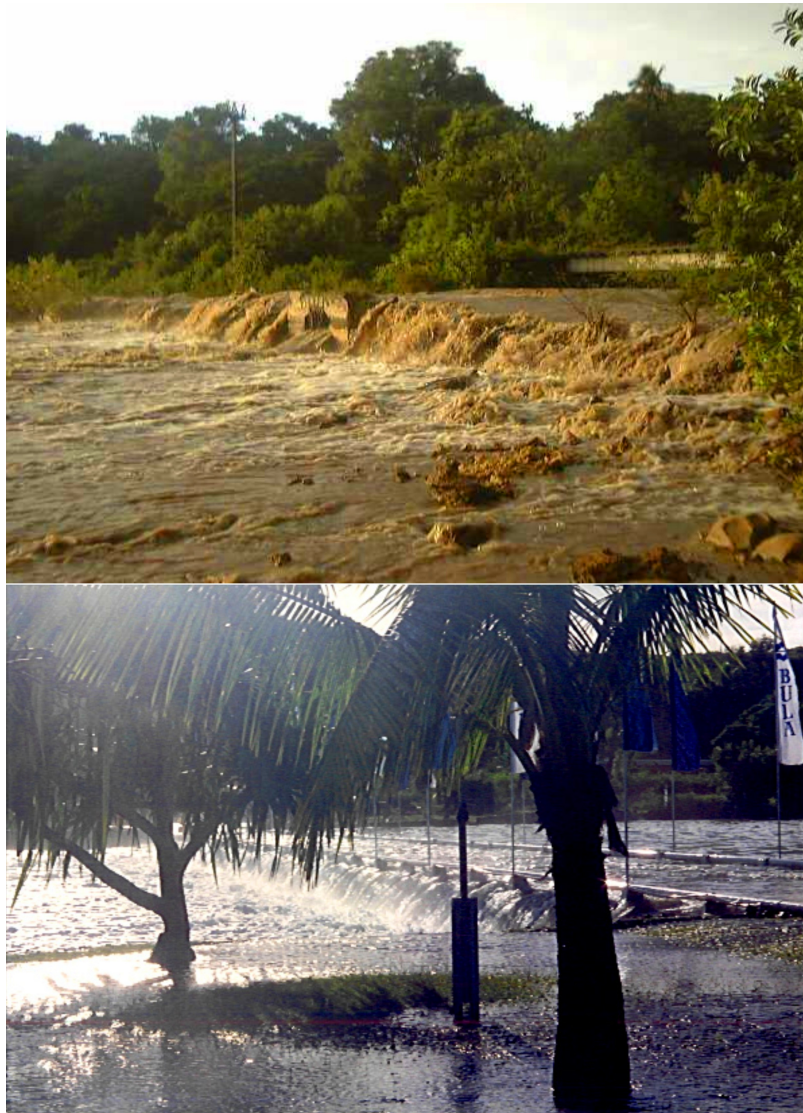
Figure 5. Top: Nalovo Creek in spate during an intense rainstorm on 4 February 2001; note the high turbidity of the water entering Yanuca Channel. Bottom: significant damming effect of the causeway in storm surge conditions during the passage of tropical cyclone Paula in March 2001. Source: Randy Thaman (USP) and the Fijian Resort.

Consequently, Nalovo Creek delivers large loads of soil material into the lagoon in storms. This is illustrated in Figure 5, showing the Nalovo Creek in flood during a heavy rainstorm on 4 February 2001. This storm was

associated with a slow moving trough of low pressure that affected much of southern Viti Levu. Heavy rain on 3-4 February led to flash flooding in the Central Division of Fiji (Fiji Meteorological Service 2001). The Nalovo Creek became a torrent within 30 minutes of intense rain and soon overflowed its road culvert into the lagoon. The torrent was highly charged with sediment, causing a turbid plume to stretch across the width of the channel to Yanuca Island. A later storm event was sampled at high stream flow on 10 April 2001 after a heavy downpour. Maximum recorded streamwater sediment concentration was 2331 mg l⁻¹ (Table 2).
