## Perth's lost guns: a geophysical case study

Andrew Pethick, Alex Costall and Tim Dean  
[Tim.Dean@curtin.edu.au](mailto:Tim.Dean@curtin.edu.au)

### Introduction

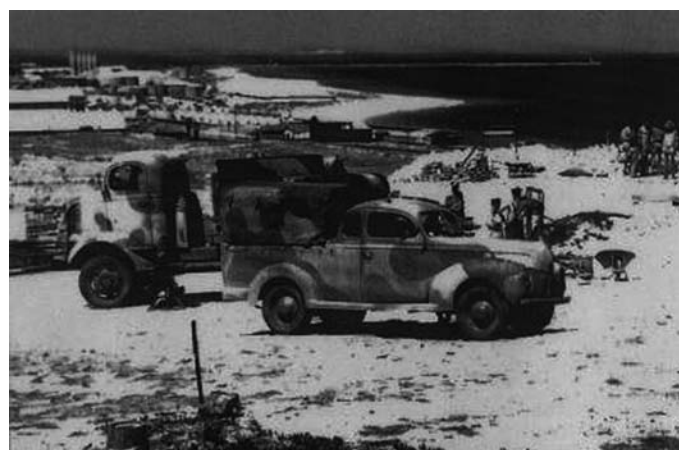
**Figure 2.** Photograph of Buckland Hill during construction of the Leighton Battery. The North Mole of Fremantle harbour can be seen in the background.

Construction began at the end of 1942 (Figure 2) with the battery becoming operational in February 1943. It consisted of two 6-inch guns (Figure 3 left panel) along with several 3.7-inch anti-aircraft guns (Figure 3 right panel). As well as the guns, over 300 m of tunnels were constructed. These tunnels are up to 10 m below the surface, and provided storage, communications, rest areas, and observation posts.

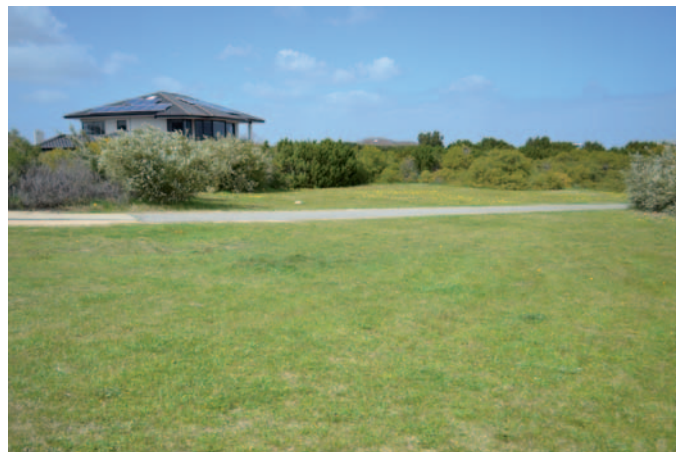
**Figure 6.** Current photo of the suspected site of the second gun emplacement. Compare this with Figure 2.

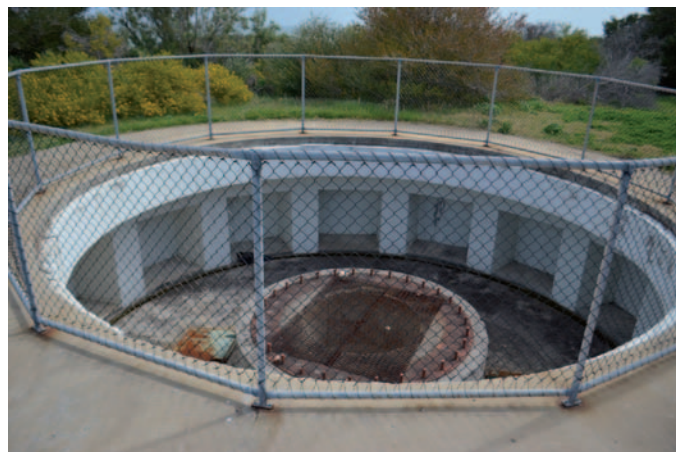
**Figure 7.** Photograph of the currently exposed gun position.

The gun emplacement consists of a ring of reinforced concrete within which the gun was mounted along with three adjacent rooms (Figure 7). By comparing the current topography of the site to historical maps, we expect the second emplacement to be buried at a depth of about 1 m. On this basis, we acquired the following data around its suspected position:
