Case study: successful disconnection of a traditional floating production storage and off-loading unit

Abstract. Decommissioning a producing asset within a low oil-price market scenario with a possibility of resuming production at a later stage is becoming a frequent task. The main objective of the offshore campaign is to release the floating production storage and off-loading unit (FPSO) at the earliest time by disconnecting all production risers, umbilical and mooring chains, and ensuring integrity of the subsea assets for future use.

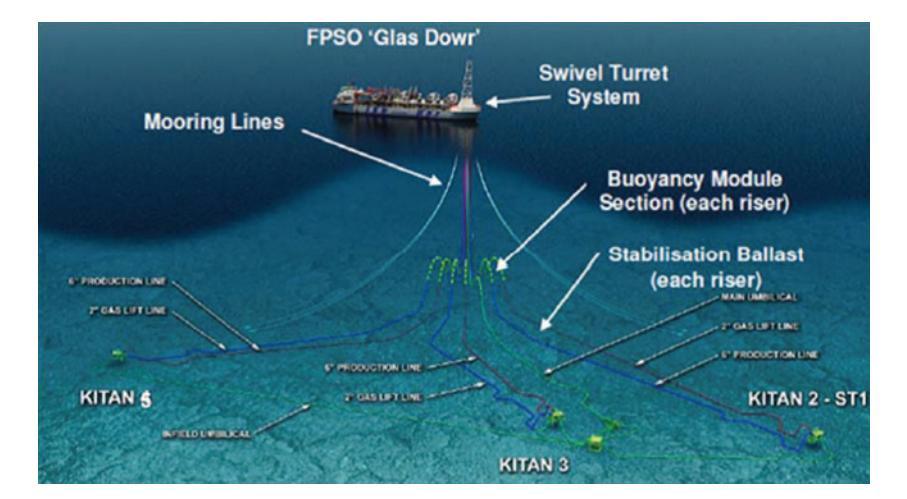
Fig. 1. Kitan Field overview.

Figures 1 and 2 illustrate Kitan field overview and the FPSO layout.

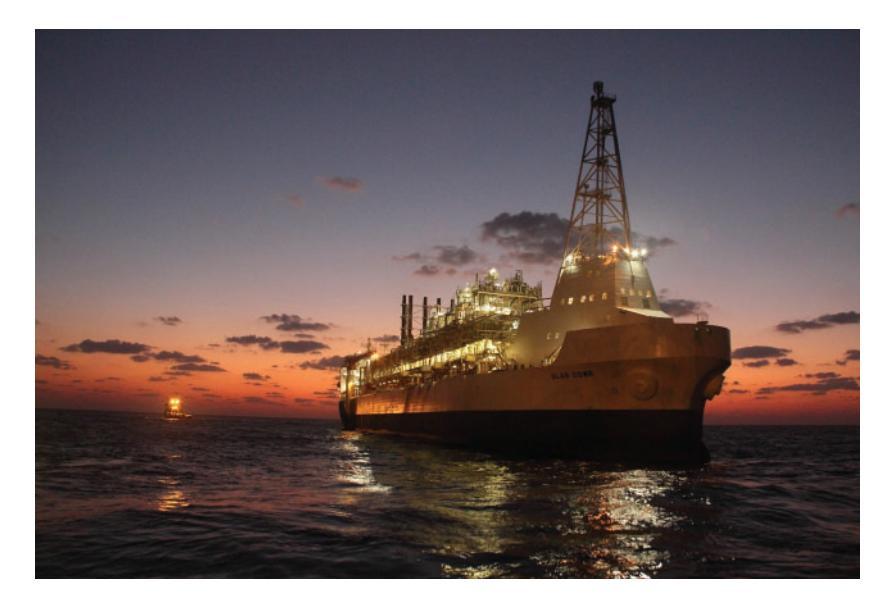
Fig. 2. Kitan Field FPSO layout – Glasdowr.

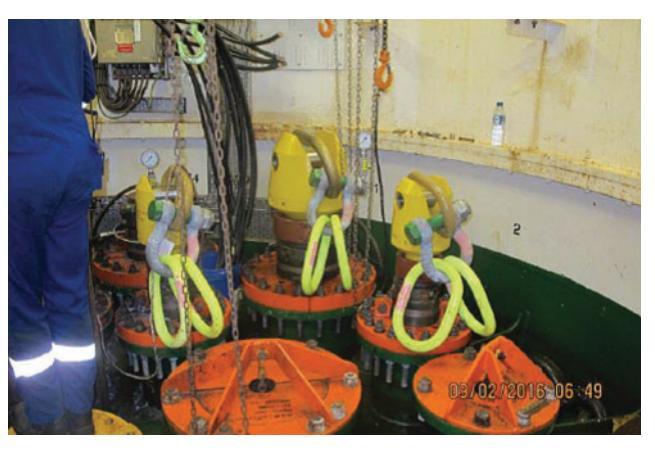
Fig. 4. Riser pull-in heads in place.

- Mobilisation and preparation of the pull-in equipment on board the FPSO (Fig. 3)
- Installation of umbilical pull-in can
- Installation of the riser pull-in heads (Fig. 4)
- · Setup sheave and route FPSO winch wire over correct riser
- Fit pull-in heads to risers
- Terminate umbilical pig tails and fit pull-in head.

The Figures 3 and 4 below show the 'as found' FPSO turret before starting the activities and post-installing the pull-in heads on risers 'end assembly'.

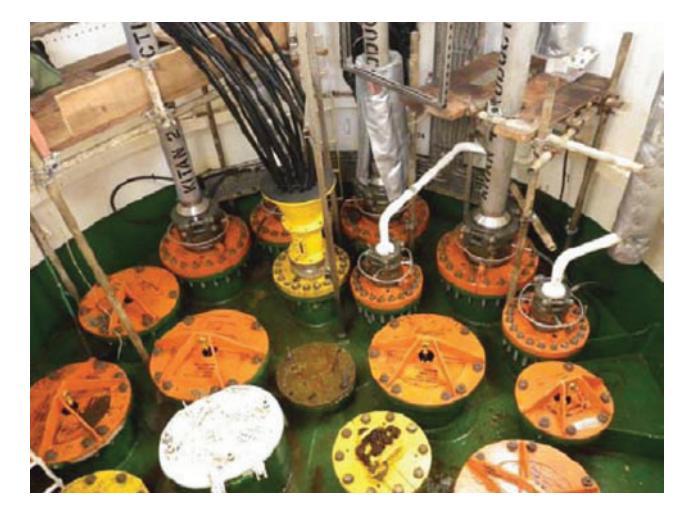
Fig. 3. As found FPSO turret.

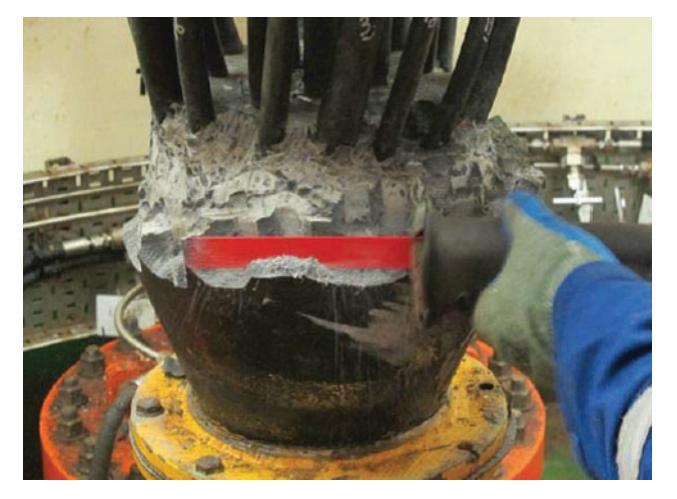
Fig. 5. Resin around control umbilical.

In order to install the umbilical pull-in heads, it was necessary to remove the resin around the termination. This activity provided access for connecting end-fittings and installation of the pull-in heads as shown in the figures below (Figs 5 and 6).

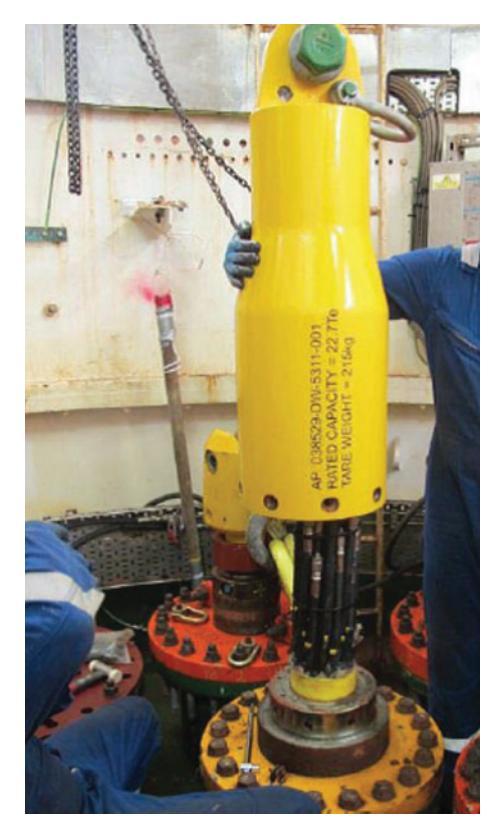
Fig. 6. Fitting of umbilical pull-in head.

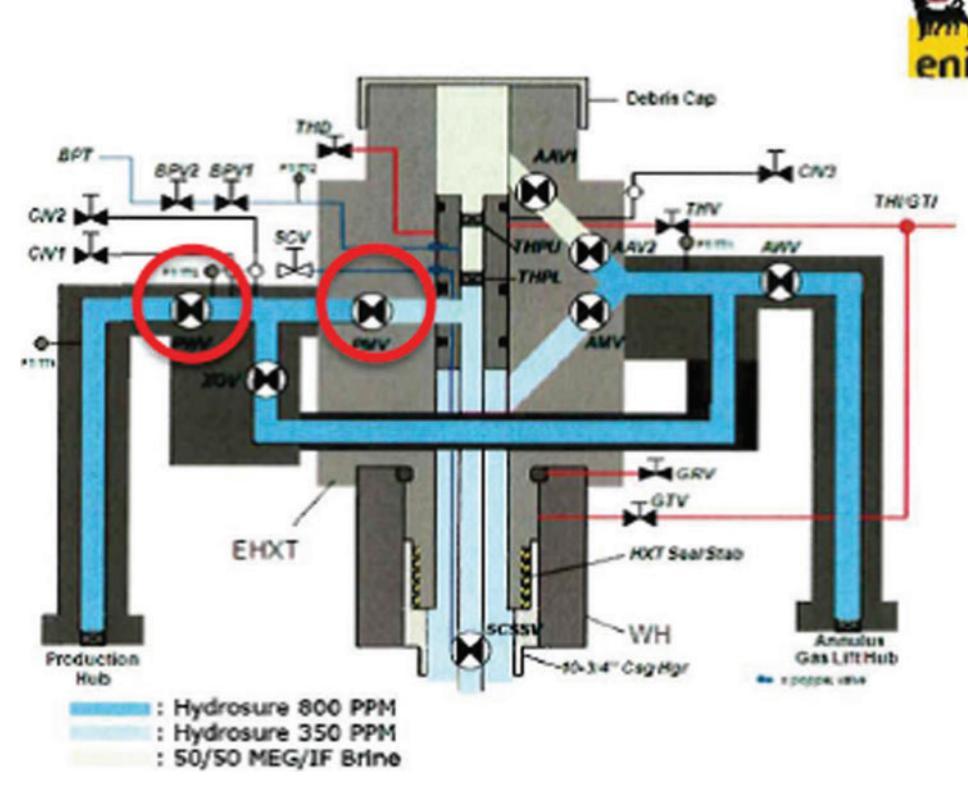
During the pre-decommissioning campaign it was not possible to confirm the pressure integrity of two Christmas tree valves on the HXT (Fig. 7). A remotely operated vehicle (ROV) survey confirmed that two valves were not in the fully closed position.

Fig. 7. Kitan Field Christmas tree.

The manual override option utilising the GVIT (Figs 8 and 9) was chosen as the first option and proved to be successful in closing both tree valves (Fig. 7) in less than 24 hours. This work was performed by ROV from the construction vessel.

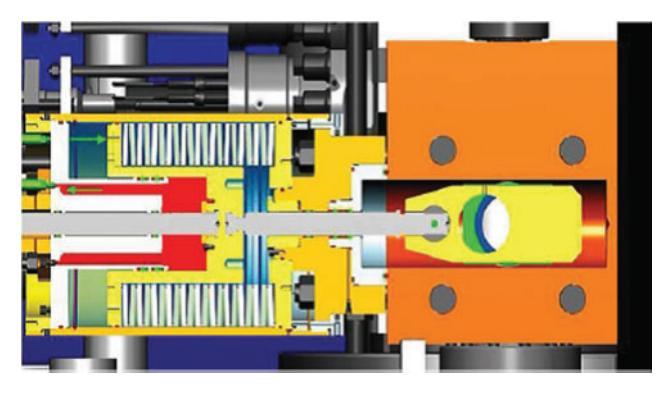
Fig. 8. Spring-loaded actuator.

The manual override option required the fabrication of a GVIT (Figs 8 and 9) specially designed to override the spring-loaded actuator and fully close the M3000 gate valve by applying a pull

force to the gate valve stem end-cap using hydraulic cylinders supplied from a ROV hot stab connection.

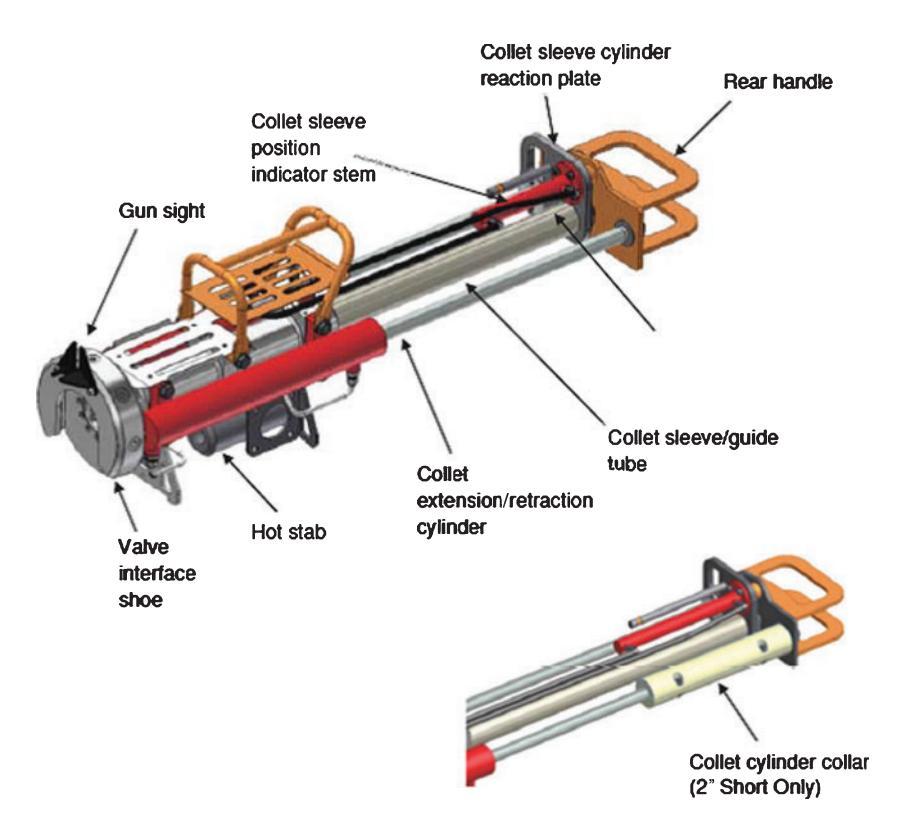
Fig. 9. Gate valve intervention tool (GVIT).

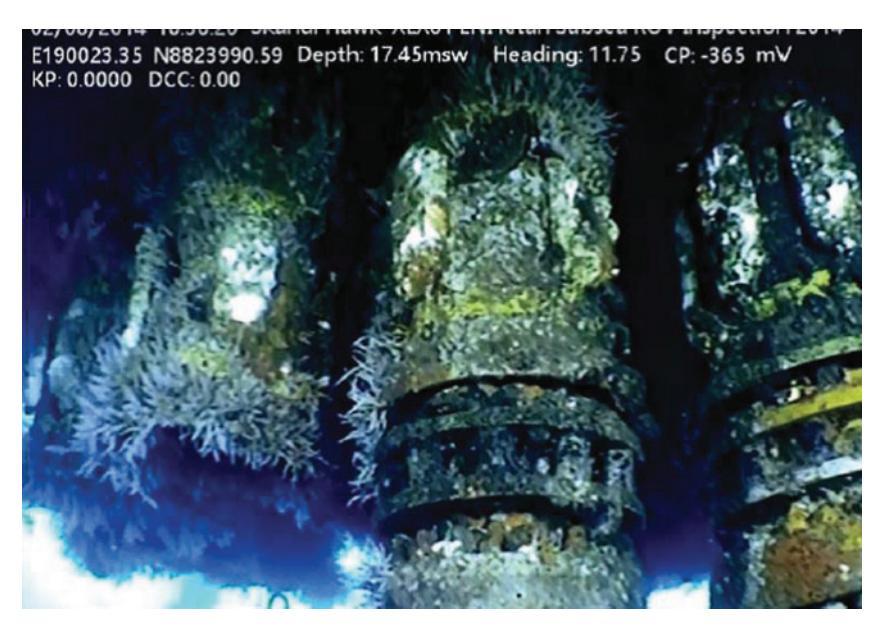
Fig. 10. BSLM marine growth.

Appropriate areas were cleaned with a 5000-psi pressure water blaster system and hand scrapers. Hand cleaning was

utilised as a contingency method only when the water blaster was unavailable. Marine growth was removed easily with the high-pressure water blaster along with the hand scrapers. Divers had minor issues during chain cleaning due to the small surface area for the diver to brace on while conducting the cleaning.

The following figures (Figs 10 and 11) show the status of marine growth on the bend stiffener latching mechanisms (BSLMs) during the initial inspection and post cleaning.

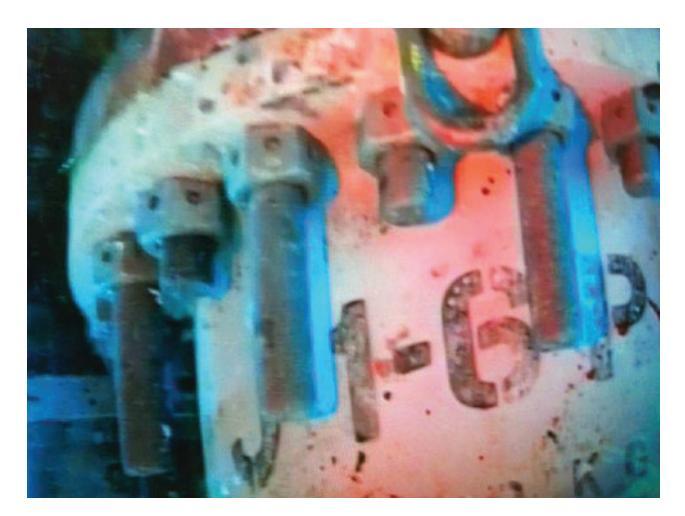
Fig. 11. BSLM post cleaning.

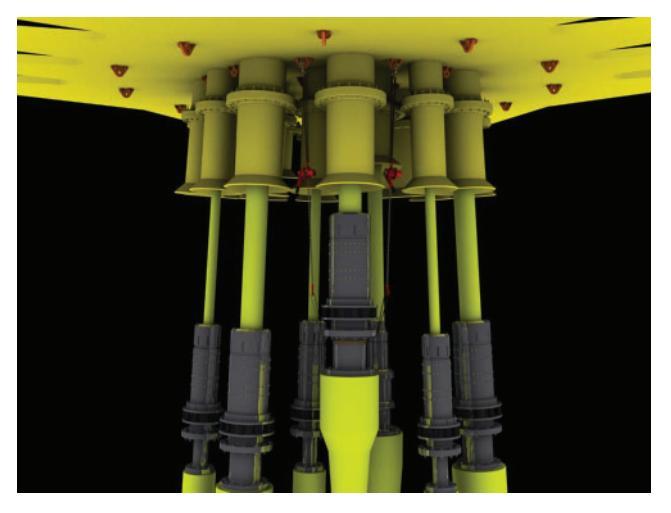
Fig. 12. Flowlines in place with male BSLM's disconnected.

Disconnection of flowline BSLMs was planned to be conducted as per the manufacturer's procedure. The following figures show the sequence of the operations (Figs 10–20).

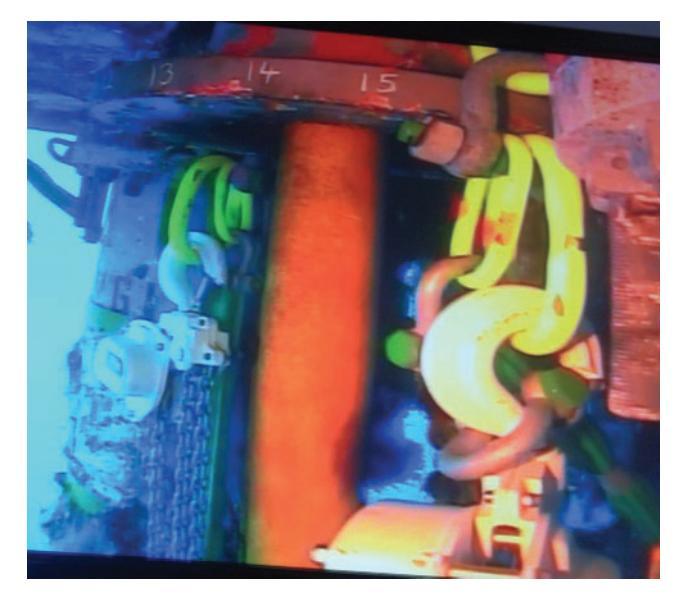
Fig. 13. Connection of adjustable rigging.

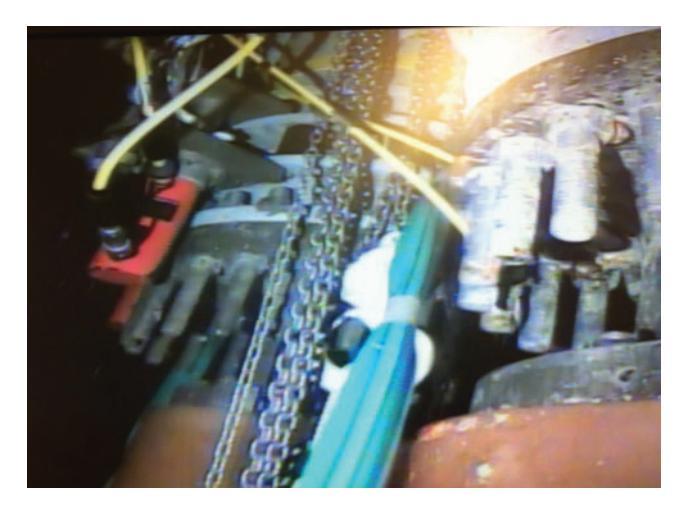
Fig. 14. Fit and stoke jacks to compress BSLM latch.

Contingency 1: Use of Hydratight jacks on the bolts joining the female BSLM to the turret J-tubes. Jacks and equipment were supplied to enable up to '100%' press. The process of transferring large numbers of jacks restrained the fitting of jacks and the absence of a work basket made the Hydratight contingency method tedious and inefficient (Figs 14–18).

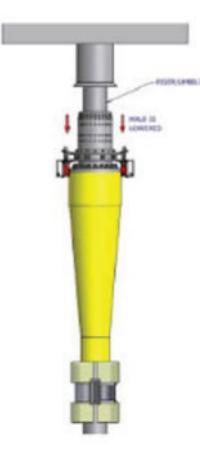
- Secure release tools around base of BSLM and function tool to release ballgrab system
- FPSO to pay out on riser to lower BSLM out of belimouth
- Depressurise and remove release tools

Fig. 16. Base case – release of BSLM as per manufacturer's manual.

However, the tool planned to release the ballgrab connector inside the BSLM did not work as effectively compared with onshore testing carried out during initial planning stages.

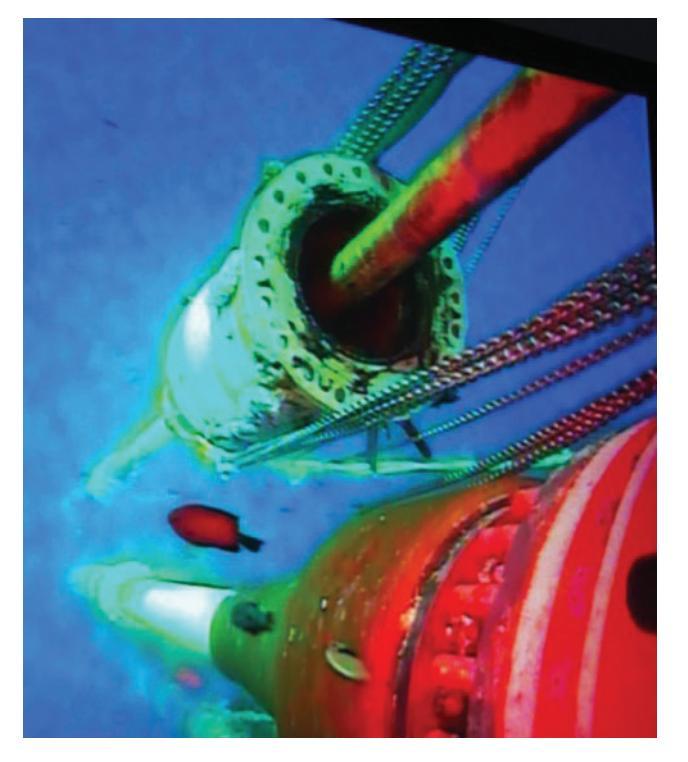
Fig. 15. Lower disconnected BSLM.

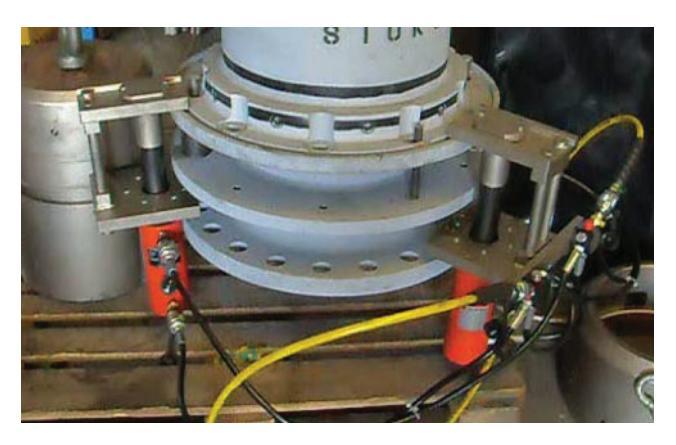
Fig. 17. Testing of Hydratight clamp mechanism.

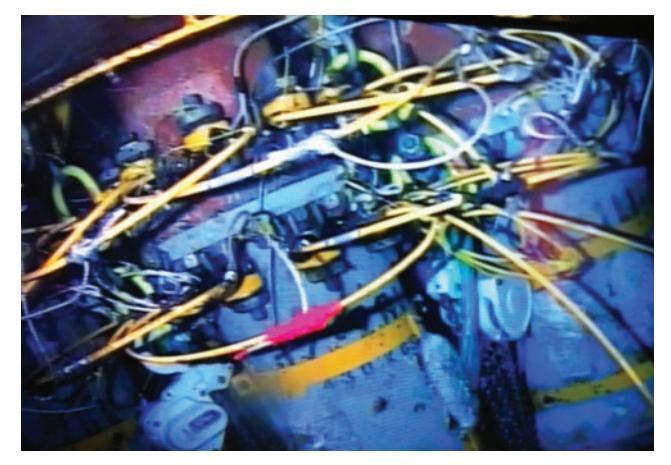
Fig. 18. Hydratight press.

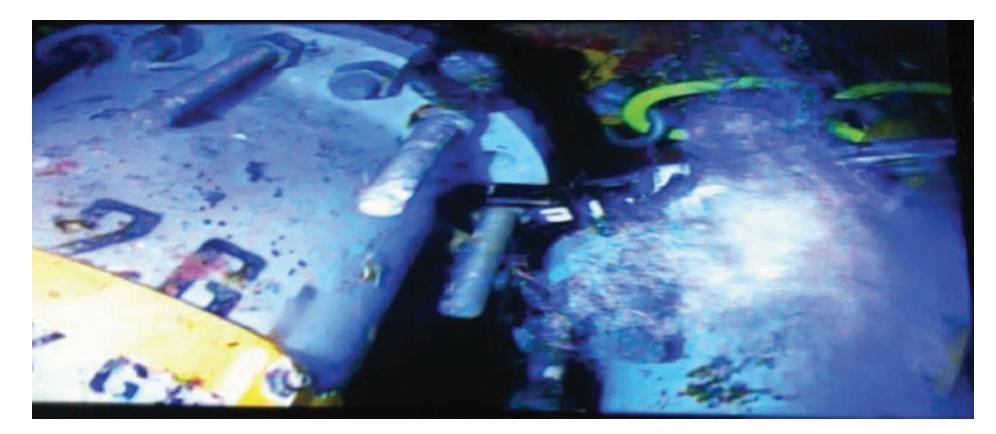
Fig. 19. Nut splitter in place.

Contingency 2: Use of a hydraulic 'nut-splitting' tool designed to work on individual nuts. This proved ineffective due to access issues, damage to splitter blades, off-centre cuts and when two opposing cuts on nuts were required there were difficulties in accessing some nuts located between J-tubes (Fig. 19).

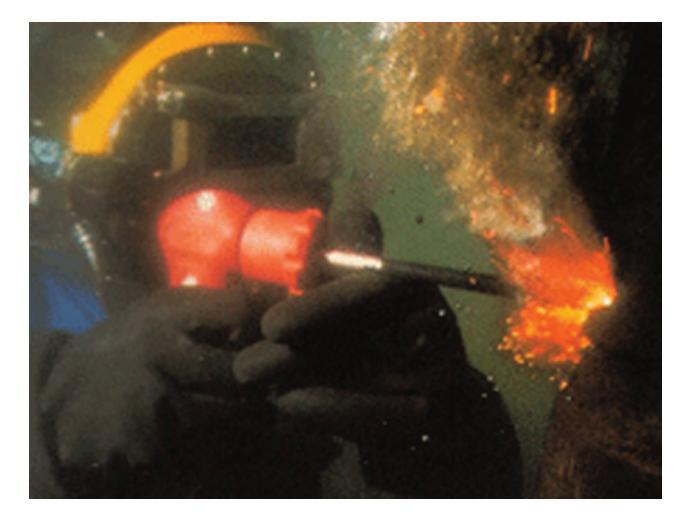
Fig. 20. Subsea oxy arc cutting.

Contingency 3: Subsea oxy arc cutting (Broco) was accepted as a proven method to remove the bolts. BSLMs

were removed using Broco on bolts within 15 h of dive time. As a precaution, a second diver monitored any gas build-up during the operation to mitigate any risk of underwater explosion (Fig. 20).

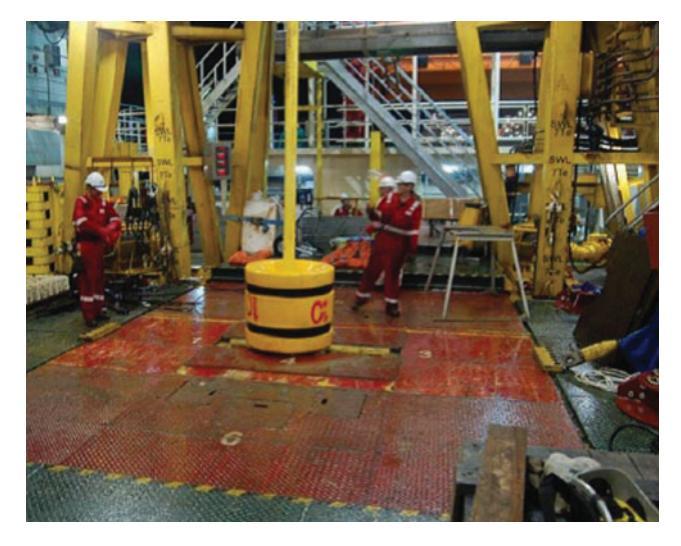
Fig. 21. Buoyancy module clamp.

FPSO winch. The recovery winch from the construction vessel (Fig. 21) was transferred using an ROV. A second ROV was kept on the touchdown point to ensure the catenary of the riser was in the acceptable limits.

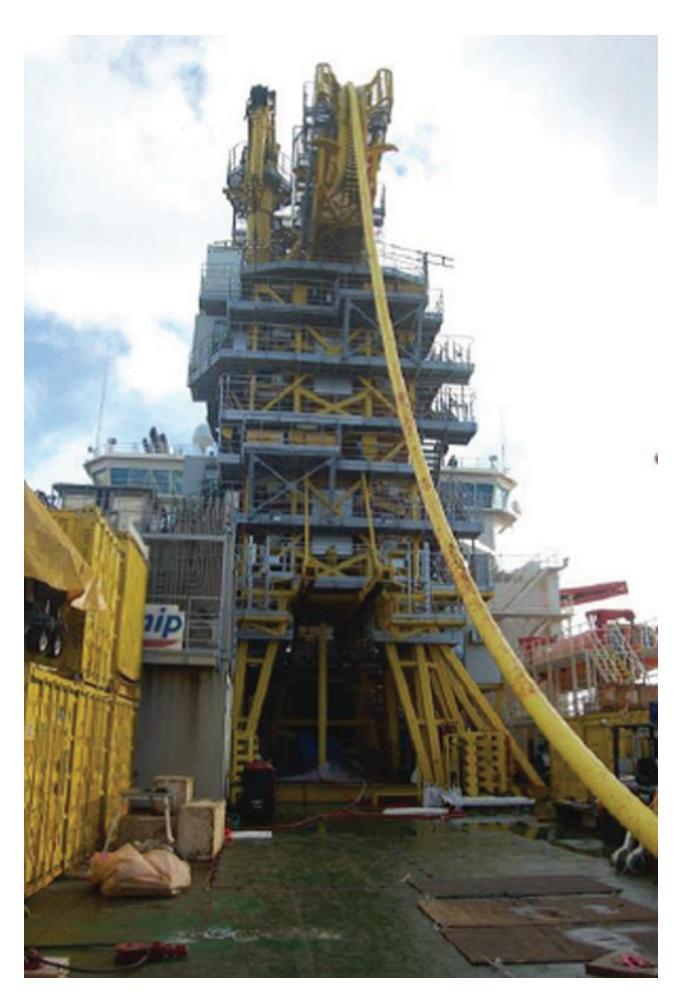
Fig. 22. Vertical lay system with flowline.

Following transfer of the riser load to the construction vessel, the riser was recovered and transferred through the vertical lay system (VLS) tower and onto the recovery reel. Buoyancy modules were removed in the work station. Once the last buoyancy module was removed, the riser was laid along the agreed abandonment route on the seabed using the VLS (Fig. 22).

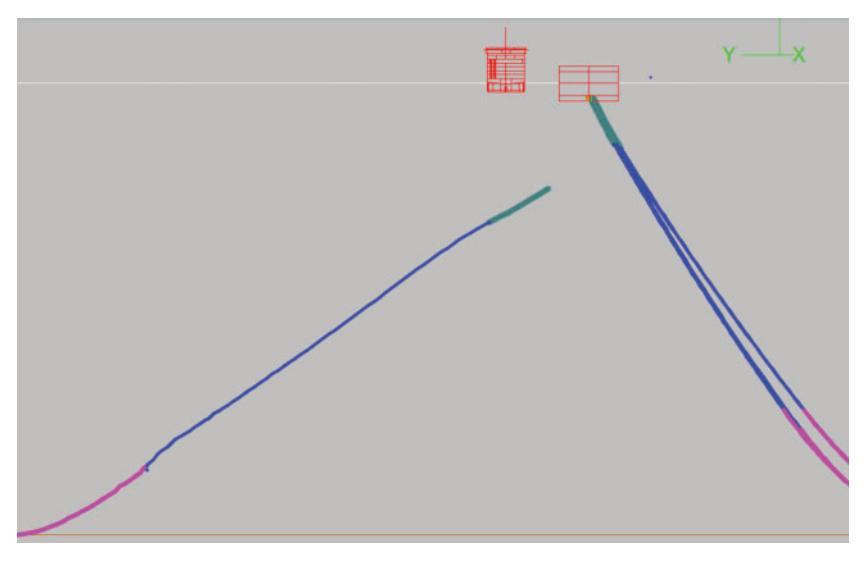
Fig. 23. Model showing the mooring catenary mid-way through freefall.

A model (Fig. 23) was created to visualise the behaviour of chain freefall. The cut location and tension in the mooring leg had few minute issues which were affecting the configuration once dropped on the seabed. The analyses also maximised the clearance of the mooring legs from the abandoned risers.

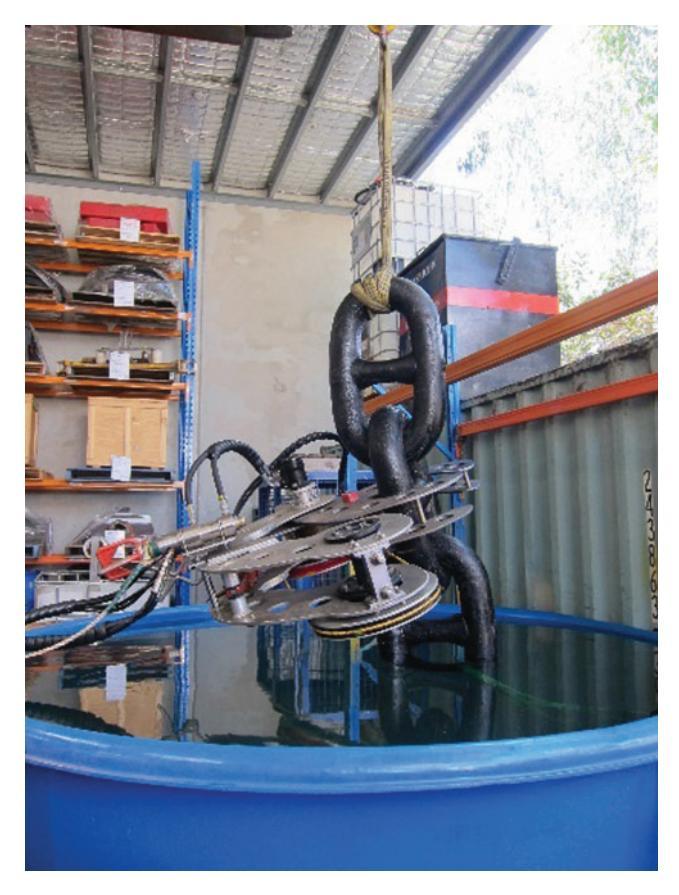
Fig. 24. Testing of diamond wire cutting tool.

Instead, some tests were performed onshore to determine the most efficient way to present the tool and cut the chain. This provided a lot of practical information on power consumption and the way to efficiently handle the tool (Figs 24–28).

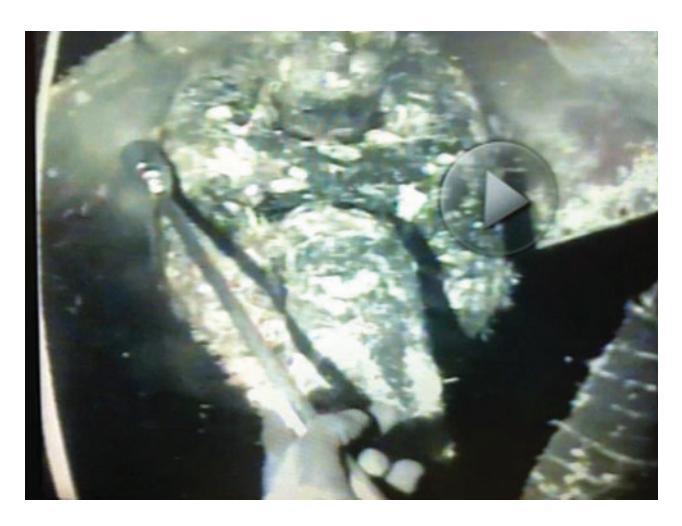
Fig. 25. Chain cleaning.

Divers were used to clean the mooring chain and chain catcher in preparation for the ROV operations.

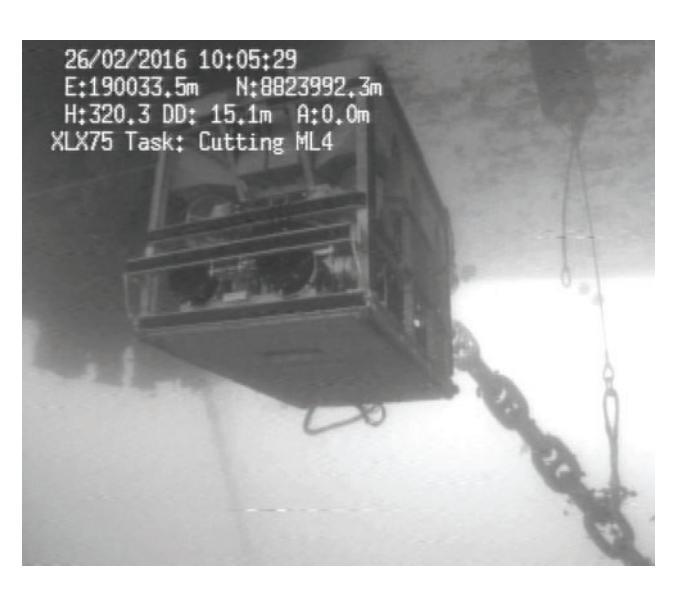
Fig. 26. ROV cutting mooring chain.

Trials were performed onsite to assess the ROV configuration with the cutting tool. As expected, the temperature rose quickly. After a few attempts, the ROV working hydraulic pressure was fine-tuned in combination with the modes of the diamond wire cutter. Understanding of the tidal currents helped to find the right launch time for the ROV to perform the necessary cuts (Figs 25–27). The ROV temperature variations did not impede the progress; however, necessary precautions were taken before the actual operations.

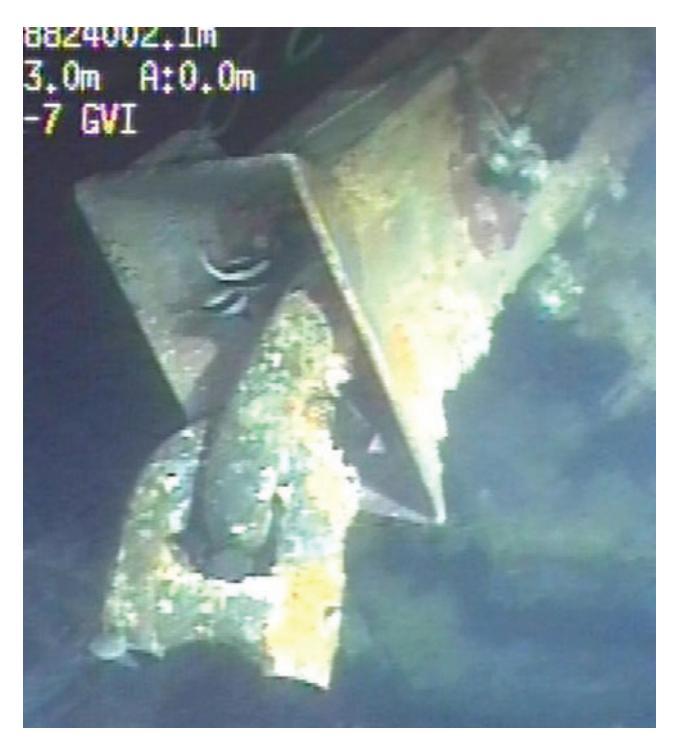
Fig. 27. Cut link of mooring chain.

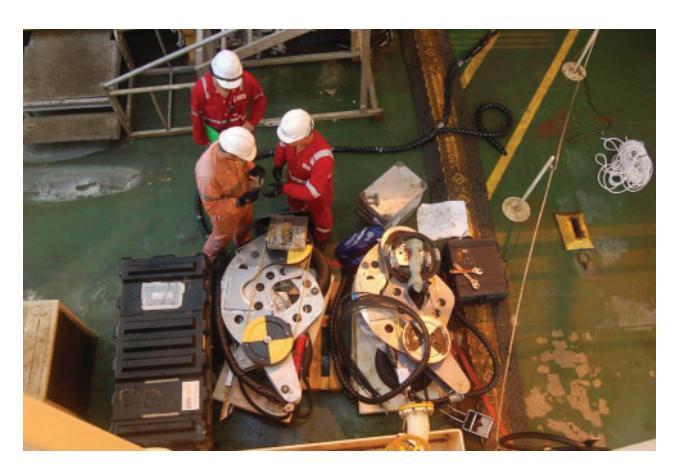
Fig. 28. Diamond wire cutting tool.

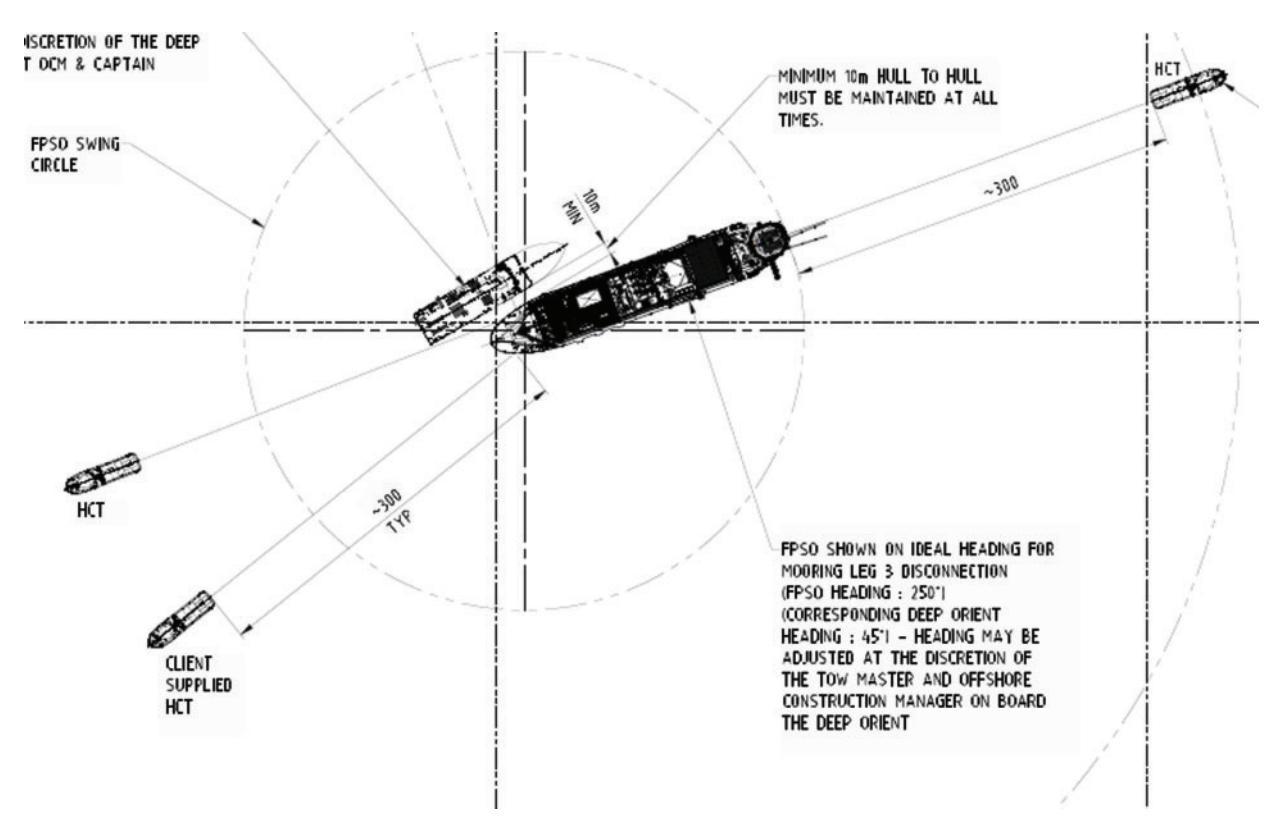
Fig. 29. HCT positions for the final chain cuttings.

Two HCTs were used to keep the FPSO in the correct position and make changes to heading, when required, during riser and mooring chain disconnections (Fig. 29).

A fulltime towmaster on board the FPSO was responsible for maintaining and handling any changes to heading, keeping a close check on tow line tensions. For the final mooring chain cuttings, an additional standby vessel became available as a third HCT along with the other two. The configuration was changed to two tugs at the bow and one tug on the stern of the FPSO.
