ACCESSORY PUBLICATION

Managing the world's most international river: the Danube River Basin

Accessory Publication

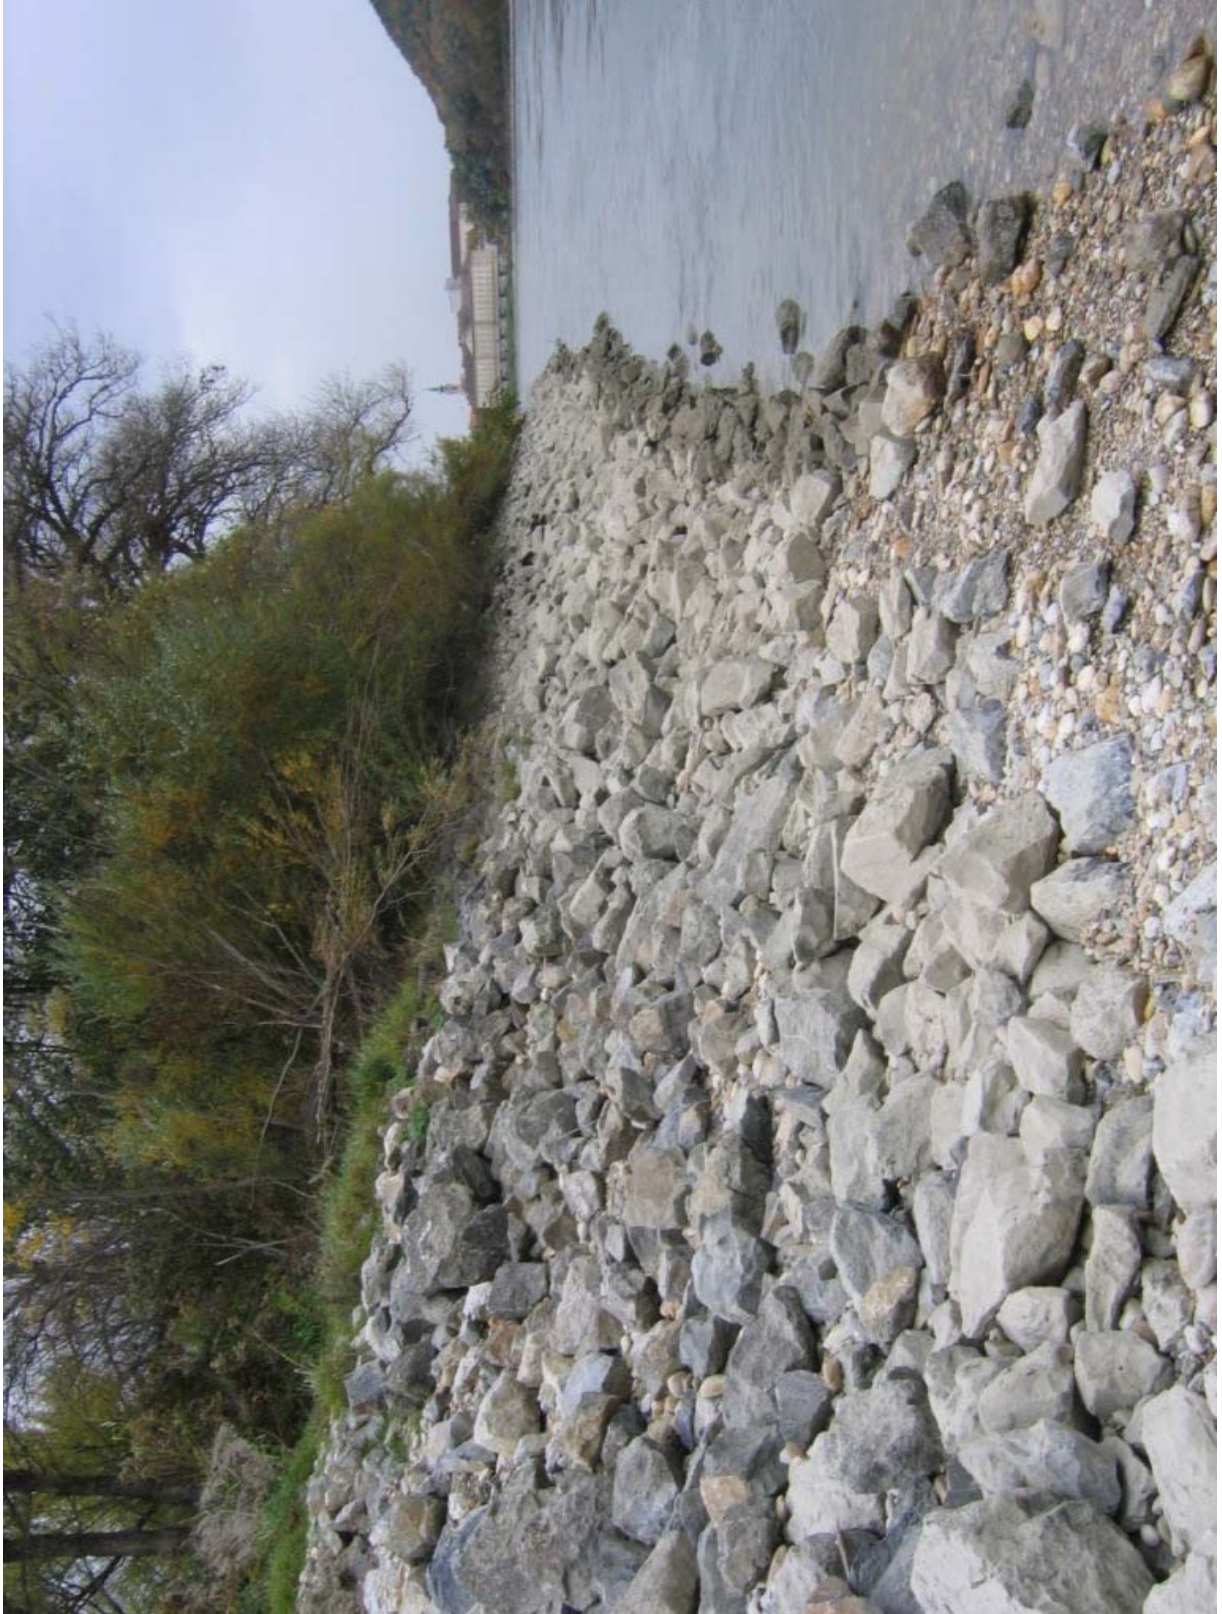
C) The Danube river bank (Rkm 1885.75 – 1882.9) before (a) and after (b) restoration. The largest restoration project along the Danube is actually carried out between Vienna and Bratislava. About 50% of the riprap will be removed to allow natural bank processes (Photos C.Baumgartner).

To enhance riverine morphodynamics, several side arms have been reconnected since 1995 (Rkm 1905.0 – 1895.5; 1905.2 – 1902.0; 1910.1 – 1906.5) and since 2005 river embankments and groynes have been removed from 2.85 kilometres (Danube Rkm 1885.75 – 1882.9) and from 1.2 km (Danube Rkm 1883.1 – 1881.9) (Accessory Publication, Part C). The long-term goal of the project is to come as close as possible to the pre-regulation status of this Danube section. Implementation is by the Austrian Waterway Agency (via donau) and Danube Floodplain National Park; subsidised by the EU LIFE-Programme.

Along the Danube natural river banks were restored within half a year with lateral erosion rates of up to 10m, though the erosion rate is currently declining (Accessory Publication, Part C).
